**HARDECKE LAKE DAM
GREENE COUNTY, MISSOURI
MO 30148**

**PHASE 1 INSPECTION REPORT
NATIONAL DAM SAFETY PROGRAM**

AUGUST, 1980

Name of Dam: Hardecke Lake Dam
State Located: Missouri
County Located: Greene
Stream: Tributary of Pomme De Terre River
Date of Inspection: July 17, 1980

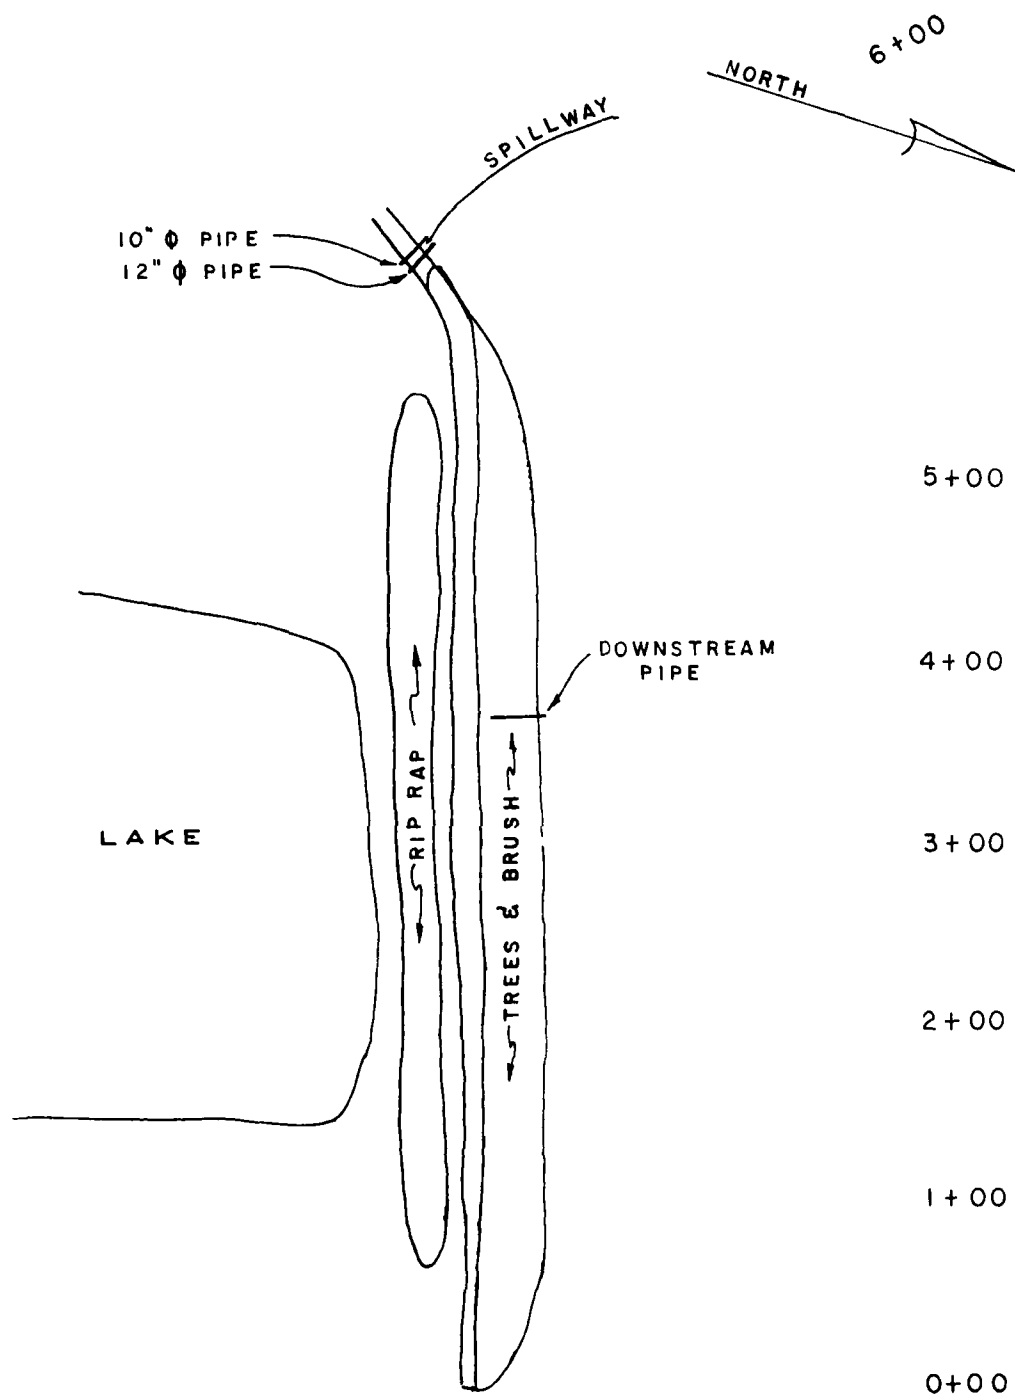
PLAN SKETCH OF DAM

The vertical alignment of the crest appeared good. An apparent sag of the vertical alignment was observed near Station 2 + 00. The elevation at this point was approximately the same as the elevation of the spillway channel at the west abutment. The horizontal alignment was good.

The owner reported that an apparent seep area exists at the downstream toe of the embankment near the center of the dam, between Station 3 + 00 and 4 + 00, and near the west abutment. He stated that the marshy area is noticeable when the lake level is at or near normal pool level. Due to the low pool level on the date of inspection, no seeps or marshy areas were observed.
